## Innovative Joint Proves Successful in Critical Slipline Project

Tom Baas<sup>1</sup>, Jeff Gardner<sup>2</sup>, Richard Mielke<sup>3</sup>

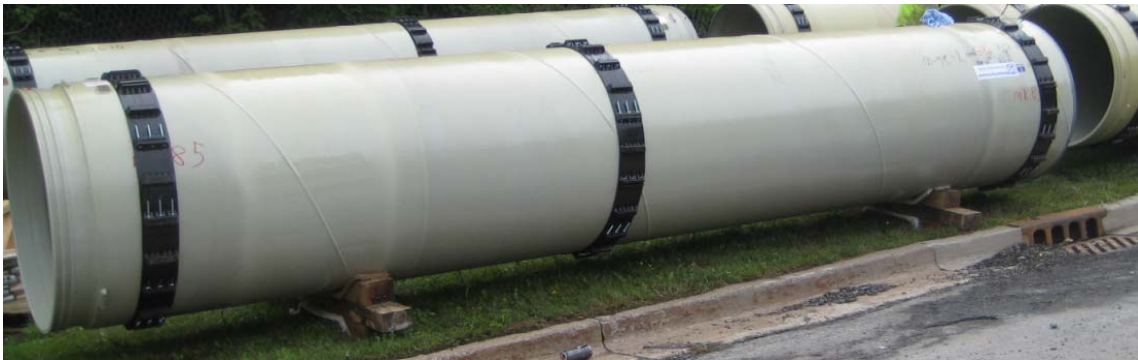
**Figure 3: Steel Pipe Liner Sections with Casing Spacers**

Once the test pipe had been pulled through a section of the distressed PCCP line, the slipling process was begun. Each section of Steel Pipe liner was fitted with either three or four sets of casing spacers, depending on the length of the section being lined Fig 3.

The casing spacers centered the Steel Pipe in the PCCP and allowed the Steel Pipe liner to easily move through and articulate at any point in the host pipe that were over-deflected or had significant joint deflections. The casing spacers also provided a consistent annular space all the way around the liner pipe sections for grouting afterwards. In addition, they electrically isolated the new carrier pipe from the old PCCP which was part of the long term corrosion control plan. Each section of liner pipe was then placed into the insertion pit on the bed of the especially designed pipe jacking sled developed by the contractor. After the first liner pipe section was pushed into the host PCCP line,

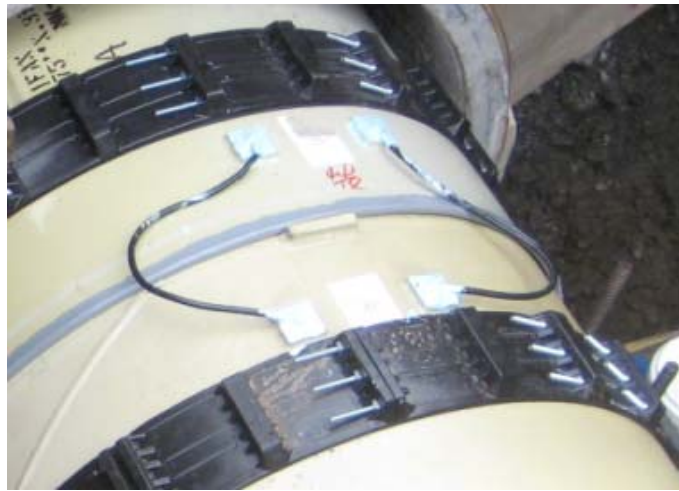
**Figure 4: Joint Bonding for Electrical Continuity**

In addition to the air-testing performed on each individual joint, every joint was also fitted with a continuous electrical bonding connection, Fig. 4, to assist in the corrosion control plan for the project developed by Brouco Services of Ottawa, Ontario. This joint bonding connection was made just prior to the engagement of the double gasketed O-ring liner pipe joint.
