Innovative Joint Proves Successful in Critical Slipline Project

ABSTRACT

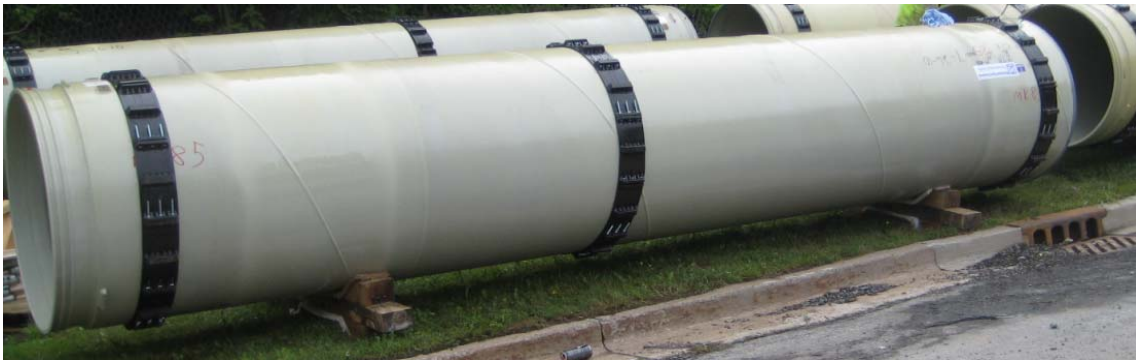
Figure 3: Steel Pipe Liner Sections with Casing Spacers

Once the test pipe had been pulled through a section of the distressed PCCP line, the slipling process was begun. Each section of Steel Pipe liner was fitted with either three or four sets of casing spacers, depending on the length of the section being lined Fig 3.

The casing spacers centered the Steel Pipe in the PCCP and allowed the Steel Pipe liner to easily move through and articulate at any point in the host pipe that were over-deflected or had significant joint deflections. The casing spacers also provided a consistent annular space all the way around the liner pipe sections for grouting afterwards. In addition, they electrically isolated the new carrier pipe from the old PCCP which was part of the long term corrosion control plan. Each section of liner pipe was then placed into the insertion pit on the bed of the especially designed pipe jacking sled developed by the contractor. After the first liner pipe section was pushed into the host PCCP line,

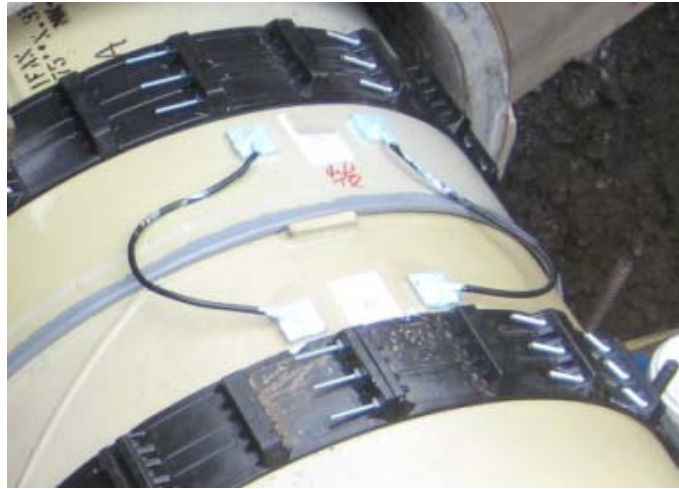
Figure 4: Joint Bonding for Electrical Continuity

In addition to the air-testing performed on each individual joint, every joint was also fitted with a continuous electrical bonding connection, Fig. 4, to assist in the corrosion control plan for the project developed by Brouco Services of Ottawa, Ontario. This joint bonding connection was made just prior to the engagement of the double gasketed O-ring liner pipe joint.
