Rehabilitation of Large Diameter PCCP: Relining and Sliplining with Steel Pipe

ABSTRACT

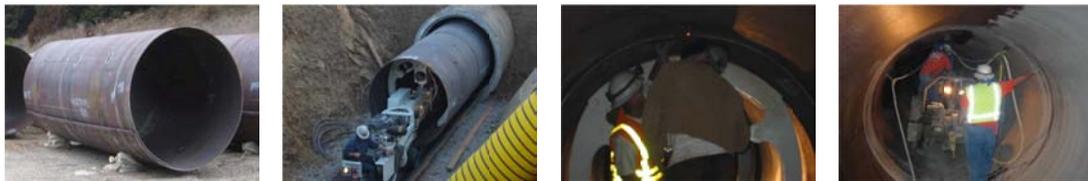
Steel Cylinder Relining: Relining consists of insertion of collapsed steel cylinders into the host pipe, re-rounding in into place and performing the necessary welding, followed by cement-grouting of the annular space between the liner and host pipe. Cement mortar lining is then applied to the inside of the cylinder. Figure 1a through 1d show the key steps involved in Relining.

Figure 1a, b, c, d: Collapsed Reliner Cylinder, Insertion of Reliner into Host PCCP, Expansion and Welding of Reliner, In-field Lining Application

Lining and Coating: The exterior of both Reliner and Slipliner cylinders is typically bare as the annular space between the liner and host pipe are grouted. Properly applied, the grout provides structural support and also prevents external corrosion. As already mentioned, Slipliner cylinders are already shop-lined with cement mortar prior to installation into the host pipe. This is not an option for Reliner cylinders, which must be cement-mortar lined in the field following re-rounding and installation into the host pipe. For very large diameter Slipliner cylinders, typically greater than the 96-inch to 120-inch diameter range, in-field application of cement-mortar lining is the norm, Figure 1d. Table 2 summarizes the key differences between Relining and Sliplining.

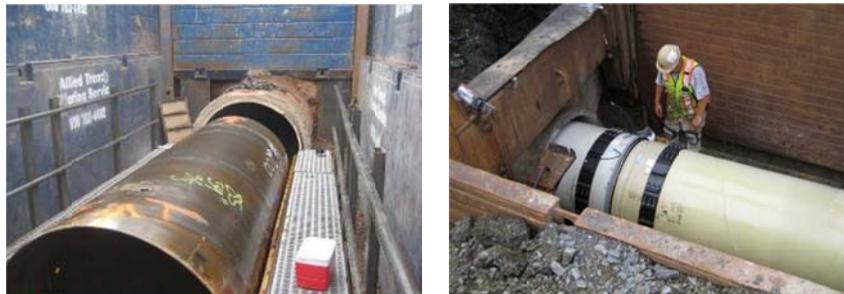
Steel Cylinder Sliplining: Sliplining involves the insertion of full sections of steel pipe into the host pipe, Figure 2a, connecting the adjoining pipe sections, and then filling the annular space with cement-grout. A cement mortar lining is then applied to the cylinder. This method also meets the AWWA M28 classification of structurally independent Class IV Linings, and is suited for the structural renewal of long lengths of a PCCP line. Due to the conventional way in which the cylinders for Sliplining are made, manufacture is faster and less labor intensive than Reliner cylinders, and therefore, usually lower cost. Installation productivity is also faster with Sliplining than Relining, discussed further in the paper.

Ambroziak et al. (2009) describe the Sliplining of 8,300-ft of 60-inch PCCP on the Superior Waterline at the City of Phoenix, Figure 2a. Bass et al. (2011) report on the Sliplining of a 48-inch PCCP transmission main at Halifax Water with a unique gasket-joint design, Figure 2b.

Figure 2a, b: Sliplining 60-inch PCCP in Phoenix, Sliplining 48-inch PCCP in Halifax, Nova Scotia (Bass 2011)

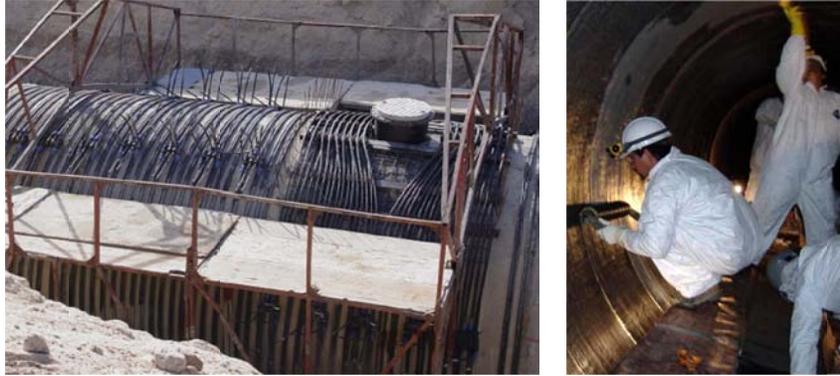
Post-Tension Tendon Repair: More often used in repairing above-ground circular structures such as tanks and silos, there are limited known uses of this technology in PCCP systems around the US. The process involves compensating for the strength lost in the host PCCP due to corroded prestressing wires with post-tensioned steel tendons placed externally around the pipe, Figure 3a. The distressed section of PCCP must be fully dug out, following which post-tensioned steel cables are wrapped around the outside of the pipe, then coated with a pneumatically-applied layer of shotcrete.

Figure 3a, b: Post-tension Tendon Repair in Libya (Elnakhat 2006), CFRP Application (Rahman 2008)

Carbon Fiber Reinforced Polymers (CFRP): First applied inside a PCCP cooling line at a nuclear power plant in Arizona in the late 1990's, carbon fiber composite repair has been used in several municipalities around the US since that time. However, many of these municipalities use CFRP as a temporary repair option until a more permanent solution such as steel cylinder Relining or Sliplining is applied. Work with CFRP is specialized and requires skilled labor (Rahman 2008, Arnold et al. 2008). Layers of epoxy-wetted CFRP are applied manually in layers, Figure 3b; the orientation of the fiber provides reinforcement to the host PCCP in the corresponding direction, while the number of layers determines the strength of the lining system.

This technology is not suited to the repair of long lengths of PCCP and whenever employed, is rarely used to strengthen more than one to five sections of the host pipe at a time. Ojdrovic and LaBonte (2008) report on four sections of distressed PCCP in a power generation plant, one of which was repaired using post-tensioning, while a different technology was employed to repair the remaining three sections. The City of Tucson has used this repair option on a few sections of 66-inch diameter PCCP (Larsen 2009). The only known large-scale application of this process has been on the Great Man Made River pipeline in Libya (Elnakhat 2006). For long-term corrosion protection, the steel hoop-tendons rely on corrosion-inhibitors and are encapsulated in polypropylene sheathing, and are not known to be cathodically protected. An advantage of this repair method is that the host pipe does not have to be placed out of service or dewatered, even though most utilities that have used this technology usually put their system temporarily out of service during repair.

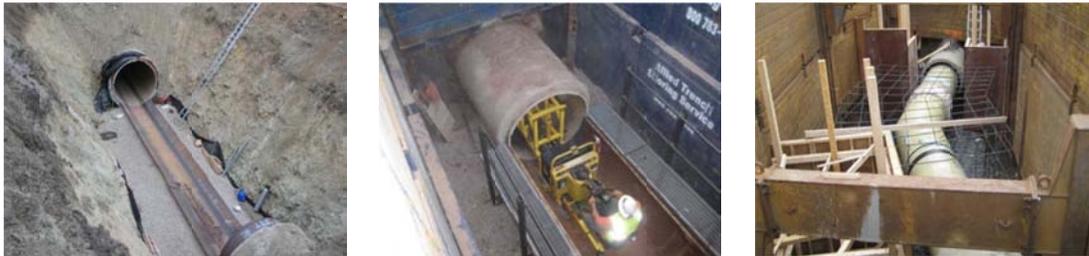
Planning: Selection of appropriate locations for insertion portals, Figures 4a, 4b and 4c, is a critical part of the planning process. They are typically placed at significant bends in the pipeline, or where surface conditions will allow. Above-ground and sub-surface conditions, existing utilities in the vicinity of the project, and depth of bury of the host pipe need to be known. Conditions both inside the host pipe and on the ground surface need to be used to determine the location of portals and the distance that can exist between portals. As already mentioned, particularly during Sliplining projects, it is important to ensure the maneuverability of the Slipliner cylinders inside the host pipe; existing collapses or excessive vertical deflections inside the host pipe should be taken into account and appropriately addressed.

Figure 4a, b, c: Insertion Portal for 96-in Dia. PCCP at SDCWA, 60-in Dia. PCCP Portal in Highly Urban Section of City of Phoenix, Insertion Portal for 48-inch PCCP at a Bend in Halifax, Nova Scotia
