Relining Prestressed Concrete Cylinder Pipe, A Manufacturers Perspective

By Greg Smith and Jeff Bruny
Northwest Pipe Company
12351 Rancho Road
Adelanto, CA
PH (760) 246-3191
FAX (760) 246-2292
Email:jbruny@nwpipe.com

This paper describes the methods of manufacturing and installing the steel liner plates to reline existing PCCP. The project consists of relining sections of a 2438 mm (96in.) and 1753 mm (69in.) pipeline. This paper will describe the unique methods of collapsing the steel cans and the rapid installation requirements required by the owner. Cooperation between the agency, manufacturer, and contractor was essential for the completion of this project on slopes as great as 38 percent. The design and installation of this liner system allowed for a minimum reduction in hydraulic capacity.

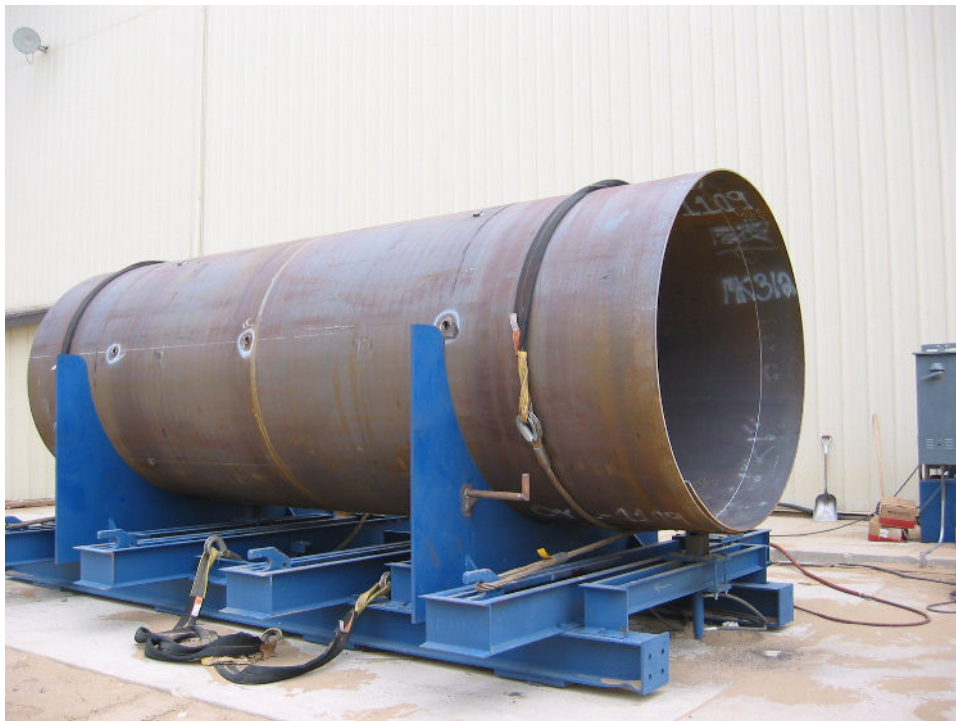
Figure 1. Collapsing Jig

- Weld a 609.6mm(24 inch) seam at the bell end
- Fit and tack two 3m(10 foot) joints to a 6m(20 foot) section
- Miter the ends if required and bell the ends square to the miter
- Weld and test the circumferential weld
- Attach the couplings and spacers
- Cut the section longitudinally and weld back with an 38.1mm(1-1/2”) offset
- Cut again longitudinally to create a 76.2cm(3”) back up bar the entire length
- Collapse the cylinders to reduce the diameter by 304.8mm(1 foot)
- Install internal tack bars and external banding straps

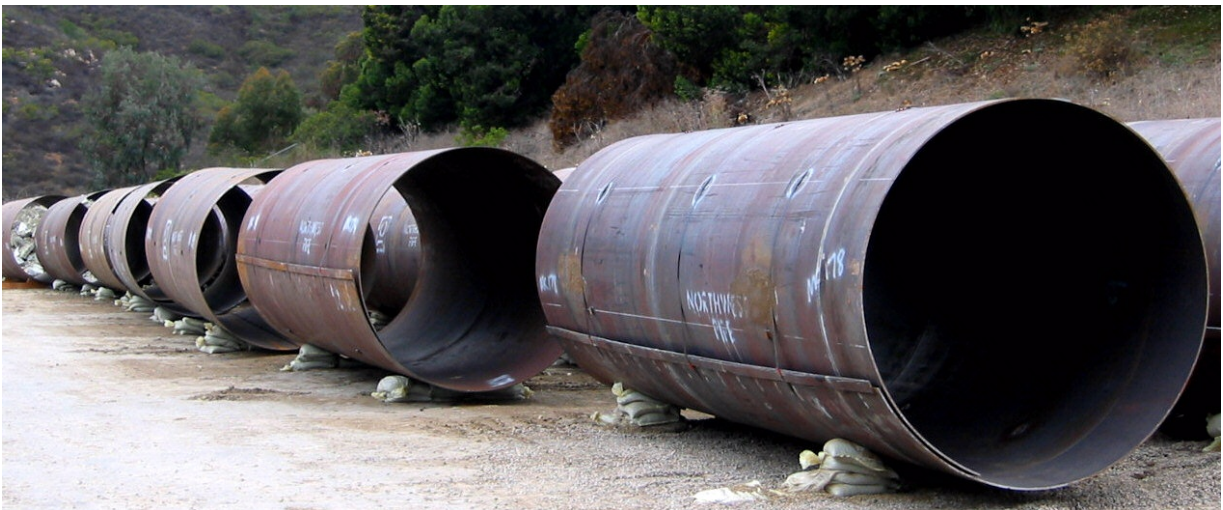
Figure 2. Stored cylinders at jobsite

Liner sections were loaded two per truck, bunked and strapped for the one hundred-mile trip to the project site. Due to the limited storage area at the portal locations, along a narrow right of way, daily deliveries were required to coordinate installation with section delivery.

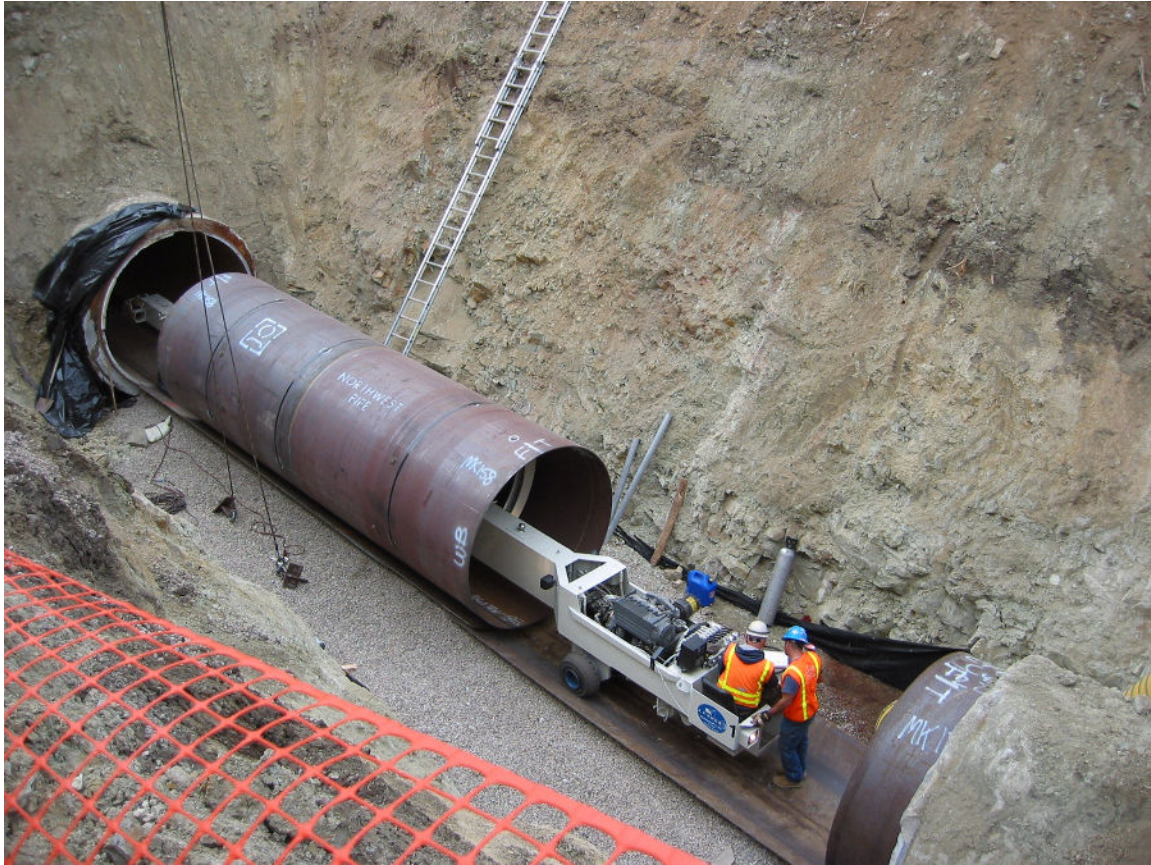
Figure 4. Pipe carrier a portal
