## Rehabilitation of Large Diameter PCCP: Relining and Sliplining with Steel Pipe

Shah Rahman<sup>1</sup>, Greg Smith<sup>2</sup>, Richard Mielke<sup>3</sup>, Brent Keil<sup>4</sup>

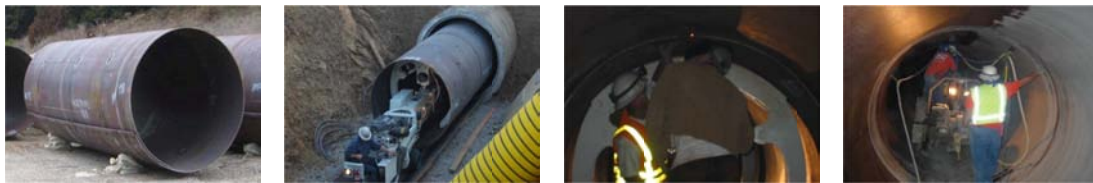
**Steel Cylinder Relining:** Relining consists of insertion of collapsed steel cylinders into the host pipe, re-rounding in into place and performing the necessary welding, followed by cement-grouting of the annular space between the liner and host pipe. Cement mortar lining is then applied to the inside of the cylinder. Figure 1a through 1d show the key steps involved in Relining.

**Figure 1a, b, c, d: Collapsed Reliner Cylinder, Insertion of Reliner into Host PCCP, Expansion and Welding of Reliner, In-field Lining Application**

**Lining and Coating:** The exterior of both Reliner and Slipliner cylinders is typically bare as the annular space between the liner and host pipe are grouted. Properly applied, the grout provides structural support and also prevents external corrosion. As already mentioned, Slipliner cylinders are already shop-lined with cement mortar prior to installation into the host pipe. This is not an option for Reliner cylinders, which must be cement-mortar lined in the field following re-rounding and installation into the host pipe. For very large diameter Slipliner cylinders, typically greater than the 96-inch to 120-inch diameter range, in-field application of cement-mortar lining is the norm, Figure 1d. Table 2 summarizes the key differences between Relining and Sliplining.

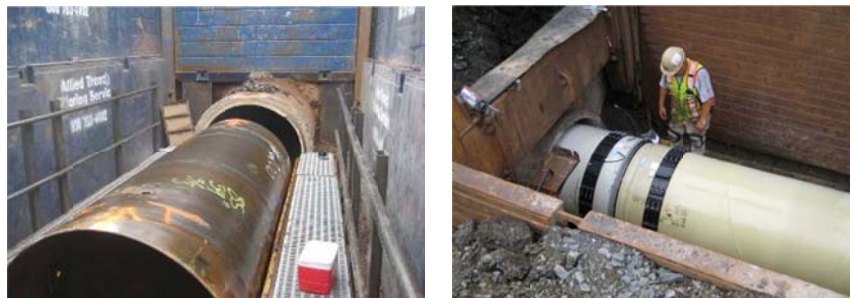
**Steel Cylinder Sliplining:** Sliplining involves the insertion of full sections of steel pipe into the host pipe, Figure 2a, connecting the adjoining pipe sections, and then filling the annular space with cement-grout. A cement mortar lining is then applied to the cylinder. This method also meets the AWWA M28 classification of structurally independent Class IV Linings, and is suited for the structural renewal of long lengths of a PCCP line. Due to the conventional way in which the cylinders for Sliplining are made, manufacture is faster and less labor intensive than Reliner cylinders, and therefore, usually lower cost. Installation productivity is also faster with Sliplining than Relining, discussed further in the paper.

Ambroziak et al. (2009) describe the Sliplining of 8,300-ft of 60-inch PCCP on the Superior Waterline at the City of Phoenix, Figure 2a. Bass et al. (2011) report on the Sliplining of a 48-inch PCCP transmission main at Halifax Water with a unique gasket-joint design, Figure 2b.

Figure 2a, b: Sliplining 60-inch PCCP in Phoenix, Sliplining 48-inch PCCP in Halifax, Nova Scotia (Bass 2011)

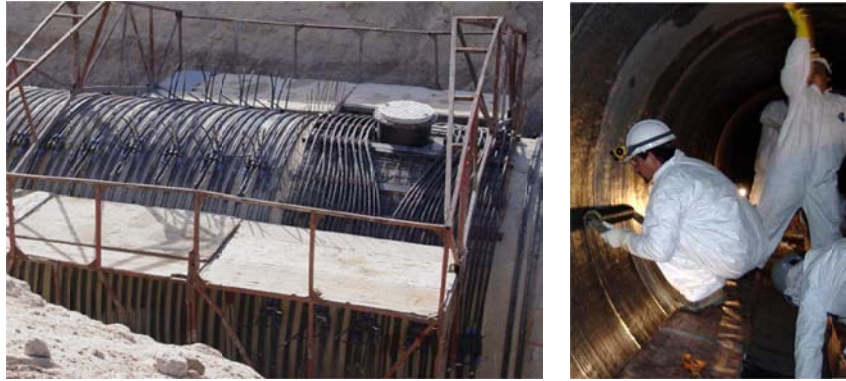
**Post-Tension Tendon Repair:** More often used in repairing above-ground circular structures such as tanks and silos, there are limited known uses of this technology in PCCP systems around the US. The process involves compensating for the strength lost in the host PCCP due to corroded prestressing wires with post-tensioned steel tendons placed externally around the pipe, Figure 3a. The distressed section of PCCP must be fully dug out, following which post-tensioned steel cables are wrapped around the outside of the pipe, then coated with a pneumatically-applied layer of shotcrete.

**Figure 3a, b: Post-tension Tendon Repair in Libya (Elnakhat 2006), CFRP Application (Rahman 2008)**

**Carbon Fiber Reinforced Polymers (CFRP):** First applied inside a PCCP cooling line at a nuclear power plant in Arizona in the late 1990's, carbon fiber composite repair has been used in several municipalities around the US since that time. However, many of these municipalities use CFRP as a temporary repair option until a more permanent solution such as steel cylinder Relining or Sliplining is applied. Work with CFRP is specialized and requires skilled labor (Rahman 2008, Arnold et al. 2008). Layers of epoxy-wetted CFRP are applied manually in layers, Figure 3b; the orientation of the fiber provides reinforcement to the host PCCP in the corresponding direction, while the number of layers determines the strength of the lining system.

This technology is not suited to the repair of long lengths of PCCP and whenever employed, is rarely used to strengthen more than one to five sections of the host pipe at a time. Ojdrovic and LaBonte (2008) report on four sections of distressed PCCP in a power generation plant, one of which was repaired using post-tensioning, while a different technology was employed to repair the remaining three sections. The City of Tucson has used this repair option on a few sections of 66-inch diameter PCCP (Larsen 2009). The only known large-scale application of this process has been on the Great Man Made River pipeline in Libya (Elnakhat 2006). For long-term corrosion protection, the steel hoop-tendons rely on corrosion-inhibitors and are encapsulated in polypropylene sheathing, and are not known to be cathodically protected. An advantage of this repair method is that the host pipe does not have to be placed out of service or dewatered, even though most utilities that have used this technology usually put their system temporarily out of service during repair.

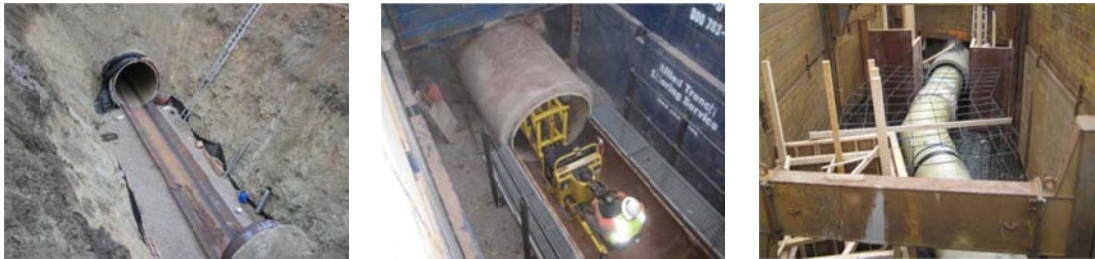
**Planning:** Selection of appropriate locations for insertion portals, Figures 4a, 4b and 4c, is a critical part of the planning process. They are typically placed at significant bends in the pipeline, or where surface conditions will allow. Above-ground and sub-surface conditions, existing utilities in the vicinity of the project, and depth of bury of the host pipe need to be known. Conditions both inside the host pipe and on the ground surface need to be used to determine the location of portals and the distance that can exist between portals. As already mentioned, particularly during Sliplining projects, it is important to ensure the maneuverability of the Slipliner cylinders inside the host pipe; existing collapses or excessive vertical deflections inside the host pipe should be taken into account and appropriately addressed.

**Figure 4a, b, c: Insertion Portal for 96-in Dia. PCCP at SDCWA, 60-in Dia. PCCP Portal in Highly Urban Section of City of Phoenix, Insertion Portal for 48-inch PCCP at a Bend in Halifax, Nova Scotia**
